Project NY 112 006-1  
Technical Note N-026  
8 May 1951

technical note:

ANDERSON-NICHOLS END-TO-END CONNECTION  
FOR PONTOON CAUSEWAYS

U.S. Naval Civil Engineering Research and Evaluation Laboratory  
Port Hueneme, California

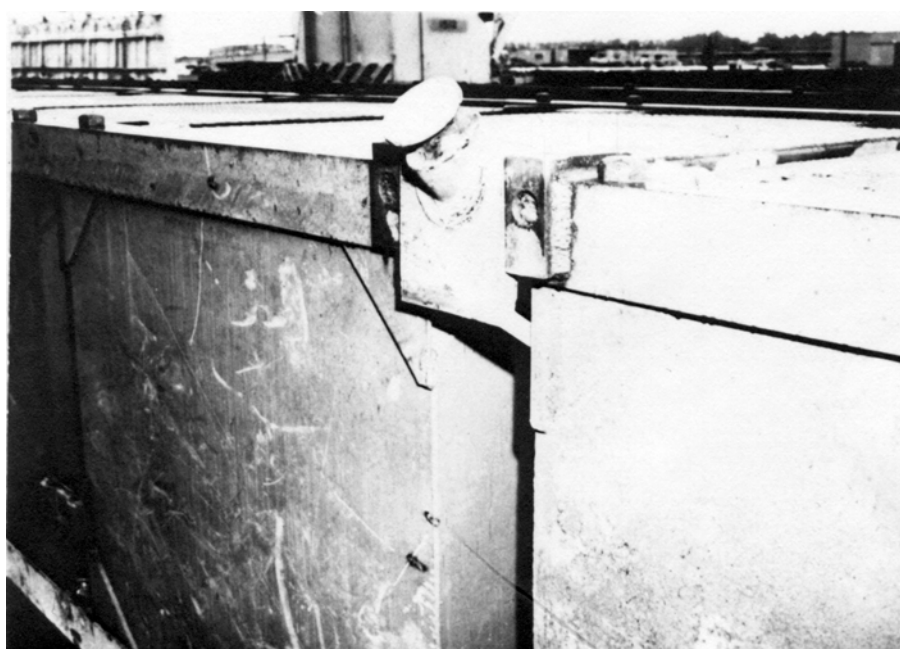
Figure 5. Special bitt fabricated from structural shape for use in pulling sections together and attaching catenary chains.

The special steel bitts were secured by means of wedge-shaped pins and side plates to the outboard pontoon deck angles. The bitts, fabricated from 5-in.-diameter round stock and 1-in.-thick steel plate, were made to fit 8-in.-wide pontoon angles. This necessitated placing the bitts three pontoons farther back from the end than was intended in the Anderson-Nichols design, since a 6-in.-wide angle is used to join the six end pontoons in a standard causeway section. In addition to holding the chain, the bitts were located so as to prevent the chain from rising onto the deck of the causeway when acting as a catenary. A saddle, designed to fit over each bitt, was formed from 4-in. steel square stock and 1-in. steel round stock. Its purpose, as shown in Figure 6, was to support the wire-rope pennant and keep it lined up with the groove in the bitt holding the end of the pennant.

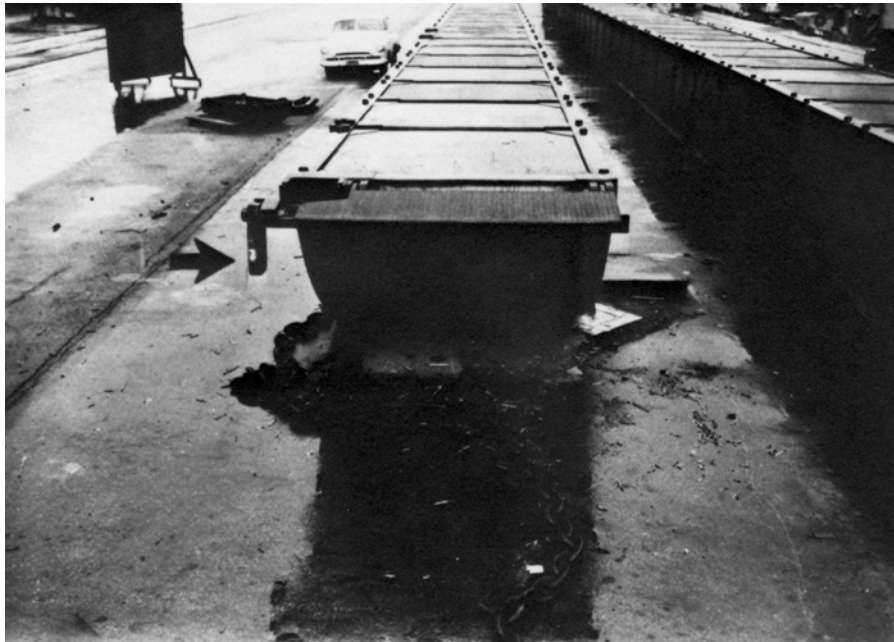
Figure 8. Steel side flap bolted to the pontoon ramp.

After completion of the beaching test, the side flaps were lengthened 12 in., the connector bolts were replaced, and the causeway connection was tested a second time for 5 hours in a surf with approximately 3-1/2-ft breakers.

The steel ramps bridged the gap satisfactorily between the causeway sections, and lengthening the side flaps prevented them from riding up onto the inverted T-7 pontoons. By keeping these flaps hooked over the edges of the pontoons lateral alignment was maintained between the causeway sections.
